Propeller Cavitation Damage

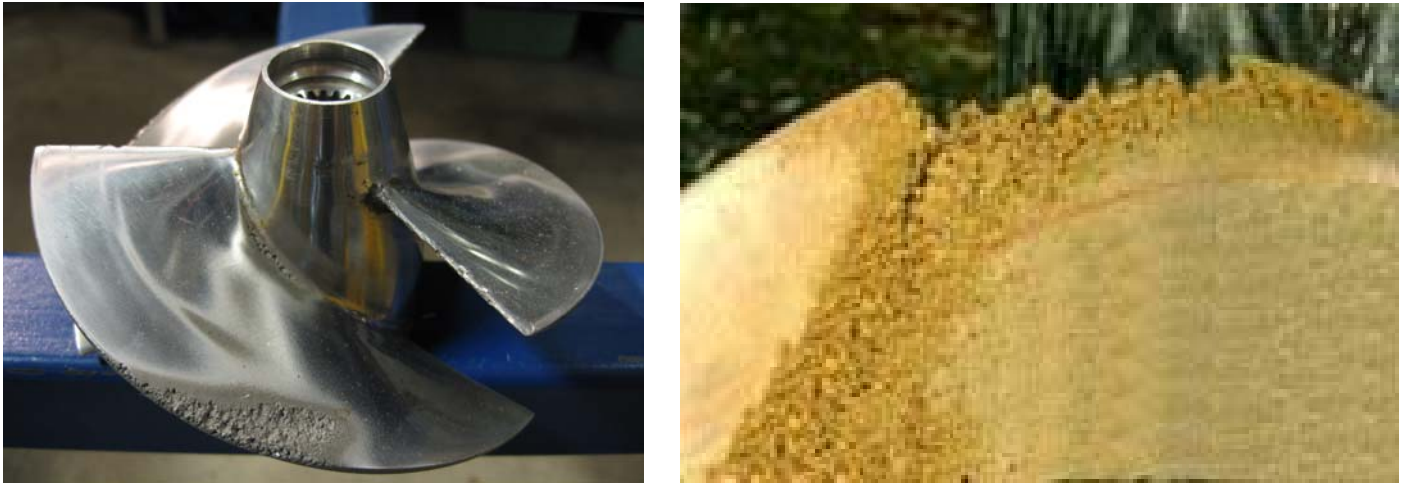
Figure 1: Left: Typical cavitation damage to the stainless steel ducted propeller from a personal watercraft. Right: Close-up of cavitation damage to a marine propeller tip.

Cavitation bubbles grow when "nuclei" are convected into regions where the pressure is at or below the vapor pressure of the liquid involved. Cavitation damage occurs when those bubbles are convected out into regions of higher pressure and therefore collapse. The rate of damage depends on the hardness of the material from which the propeller is made. Even very hard materials are susceptible to cavitation damage. Figure 1 (left) shows cavitation damage to a stainless steel marine personal watercraft propeller. It provides a good example of typical cavitation damage. Note the extensive surface damage at the mid-chord near the propeller tip. Note also the crystalline appearance of this damage that is so typical of the surface fatigue failure which cavitation causes. The damage is the result of the collapse of a tip vortex originating at the sharp corner where the propeller leading edge meets the propeller tip. When that corner is rounded off the vortex is less intense and the damage is reduced. Figure 1 (left) also shows similar but lesser damage at the root due to the root vortex in the junction of the blade and the hub.

Figure 1 (right) provides an example with more extensive damage to the tip of a bronze propeller. This example clearly shows how both the performance and structural integrity of the propeller may be impaired by the cavitation.
