## Cavitation Damage

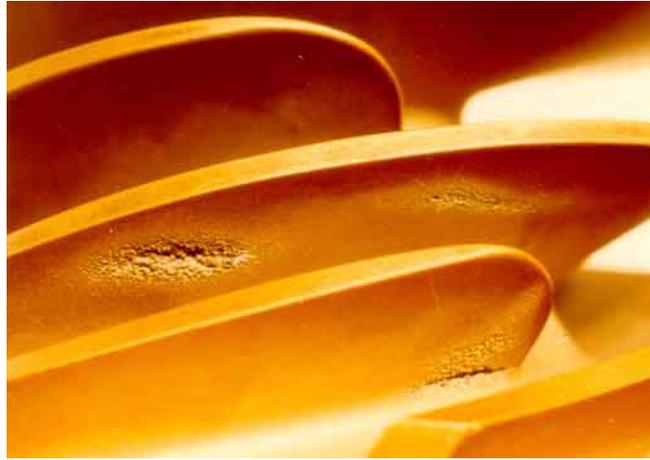
Figure 1: Photograph of localized cavitation damage on the blade of a mixed flow pump impeller made from an aluminium-based alloy.

fatigue failure. To illustrate this, a photograph of localized cavitation damage on the blade of a mixed flow pump, fabricated from an aluminium-based alloy, is included as figure 1. More extensive damage is illustrated in figure 2 which shows the blades at discharge from a Francis turbine; here the cavitation damage has penetrated the blades. Cavitation damage can also occur in much larger scale flows. As an example, figure 3 shows cavitation damage suffered by a spillway at the Hoover dam (Warnock 1945, Falvey 1990).

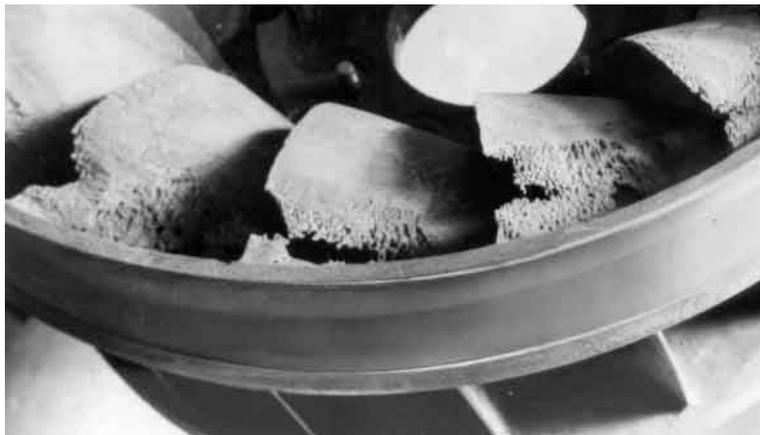
Figure 2: Cavitation damage on the blades at the discharge from a Francis turbine.

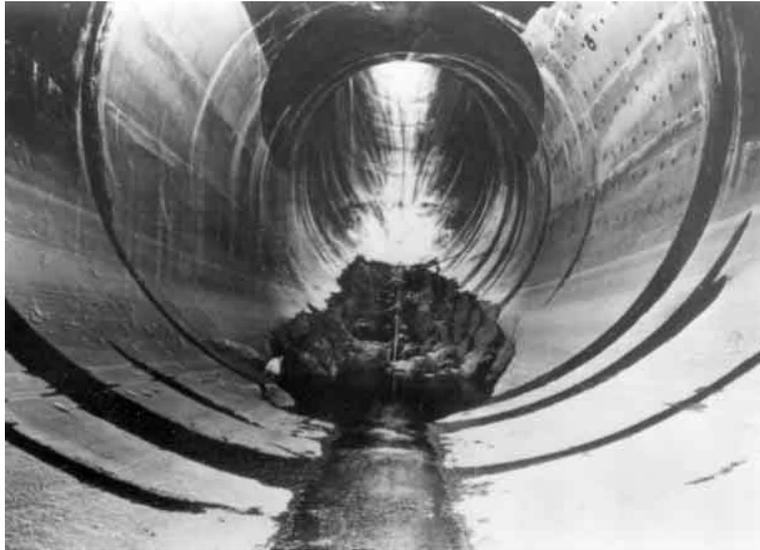
Figure 3: Cavitation damage to the concrete wall of the 15.2 m diameter Arizona spillway at the Hoover Dam. The hole is 35 m long, 9 m wide and 13.7 m deep. Reproduced from Warnock (1945).
